**Kingdom Dam Phase II Report – Vol. II
Hydraulic and Hydrologic Supplement**

Kingdom Dam on Lincoln Pond

**Town of Elizabethtown
Essex County, New York**

**Re: Kingdom Dam Phase 2 Report – Vol. 2: Hydrologic and Hydraulic Supplement, Lincoln Pond, Essex County, New York
CHA Project No.: 15470**

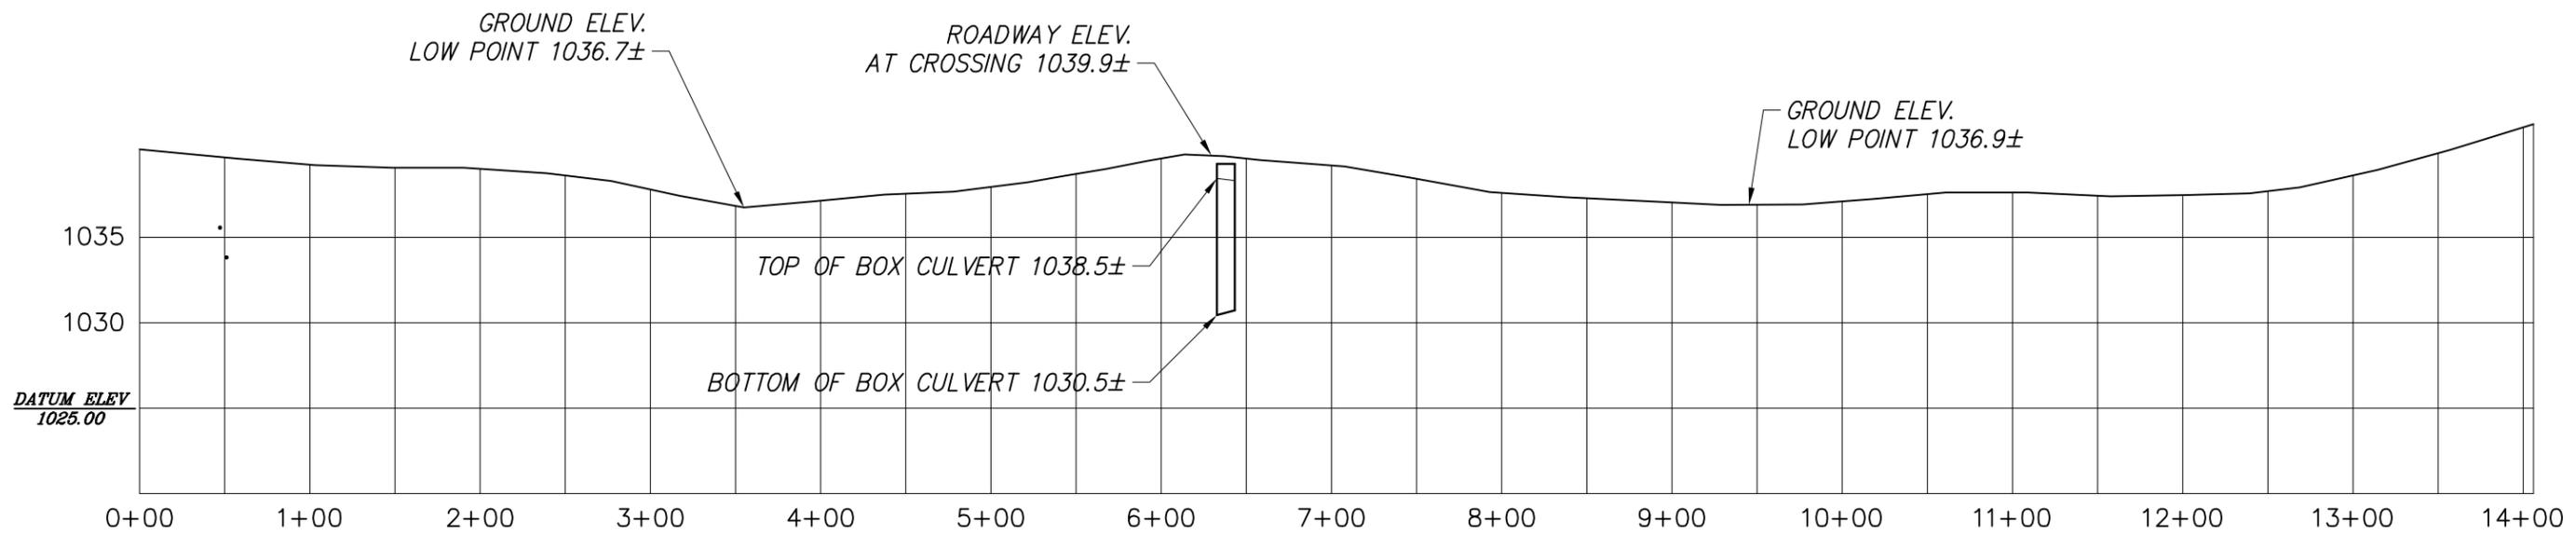
PROJECT NO. 15470
DATE: 02/22/07
FIGURE 2

Lincoln Pond is divided into two (2) separate basins by a causeway which carries Lincoln Pond Road over the waterway. The causeway is armored on both sides with riprap to protect against shore erosion. For the purposes of this report the southern basin will be referred to as the upper pond and the northern basin will be the lower pond. The upper and lower ponds are connected by a three (3) sided concrete box approximately ten (10) feet wide by eight (8) feet tall. The profile of the causeway has a low point on either side of the culvert; the first is located approximately 280 feet west of the culvert at an elevation of 1036.7 feet, and the second is located approximately 300 feet east of the culvert at elevation 1036.9 feet

(See Figure 2 – Lincoln Pond Causeway Elevation). Most of the volume of the upper pond is contained by the natural topography of the area while the lower pond was a stream corridor surrounded by shallow wetlands before the construction of Kingdom Dam. Although each basin is fed by a number of small streams, the main tributaries are Brandy Brook in the upper pond and Cold Brook in the lower pond.

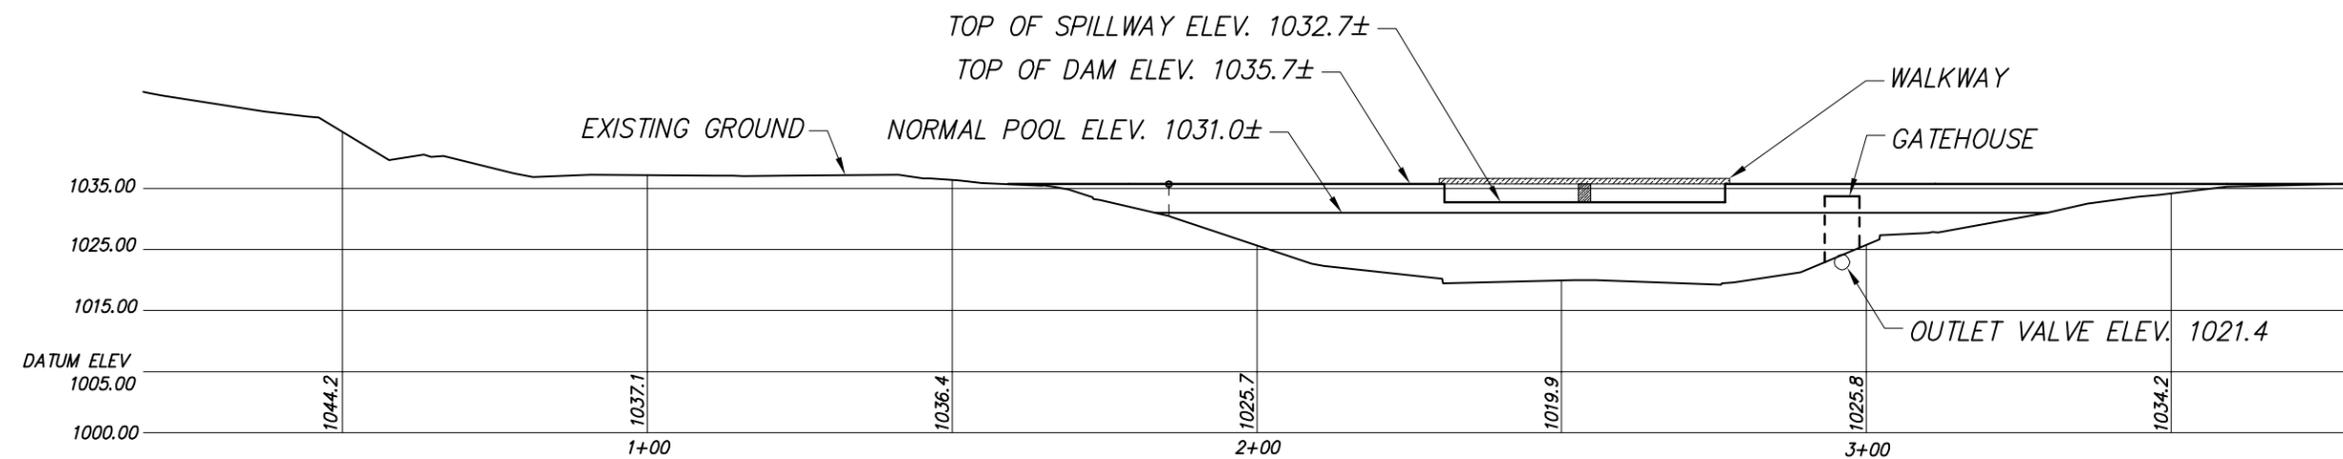
FIGURE 3

Data in Table 2 on the following page was gathered during a CHA survey of Kingdom Dam in April, 2006. For the purposes of the assessment, Kingdom Dam is assumed to have a single spillway which operates in conjunction with a three (3) foot gate valve to maintain water levels in Lincoln Pond. This spillway is composed of two (2) 21.5 foot long sections which are approximately two and a half (2.5) feet wide at their crest and have a slightly rounded profile. The spillway sections are divided by a central pier approximately two (2) feet wide, which supports an access walkway. The top of dam is defined as the average top of the concrete on either side of the spillway and is located approximately three (3) feet above its crest (See Figure 3 – Kingdom Dam Elevation). In addition, the invert of the three (3) foot diameter gate valve mentioned above is located approximately 11 feet below the spillway crest. This valve is generally used to maintain water surface elevations during the drier months of the year, and also represents the primary method of drawdown for Lincoln Pond.

Dam Component	Elevation (feet – NGVD 29)
Downstream Toe of Slope	1015.0 ±
Maintenance Gate Valve	1021.4 ±
Spillway Crest	1032.7 ±
Top of Dam	1035.7 ±

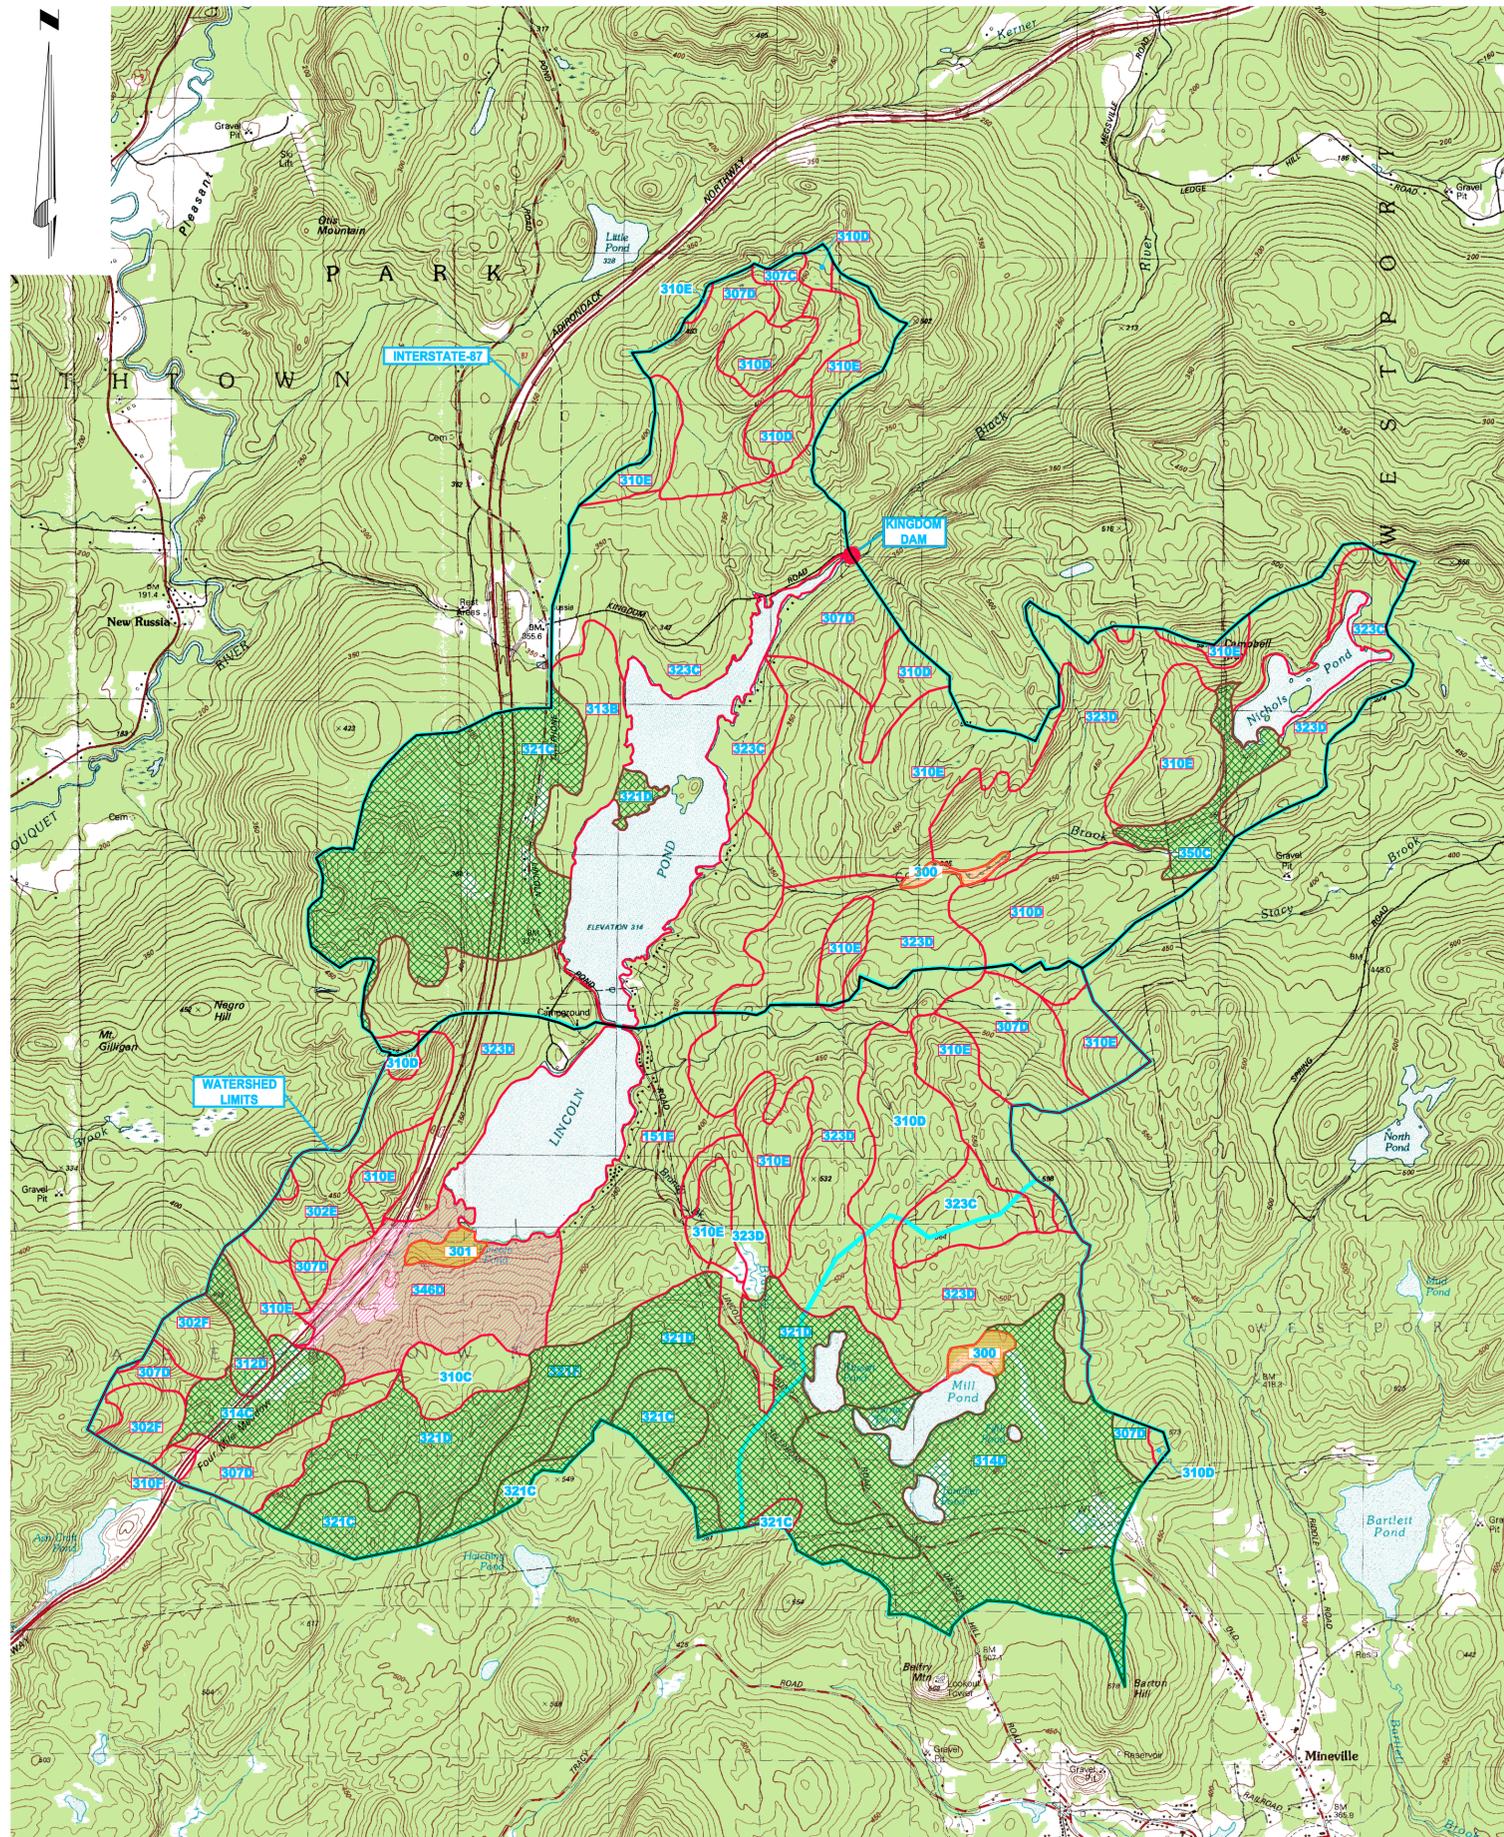
FIG. 4

HSG types A, B, C and D compose approximately 3.5%, 22%, 74% and 0.5% of the watershed, respectively (See Figure 4 – USDA Soils Classification).

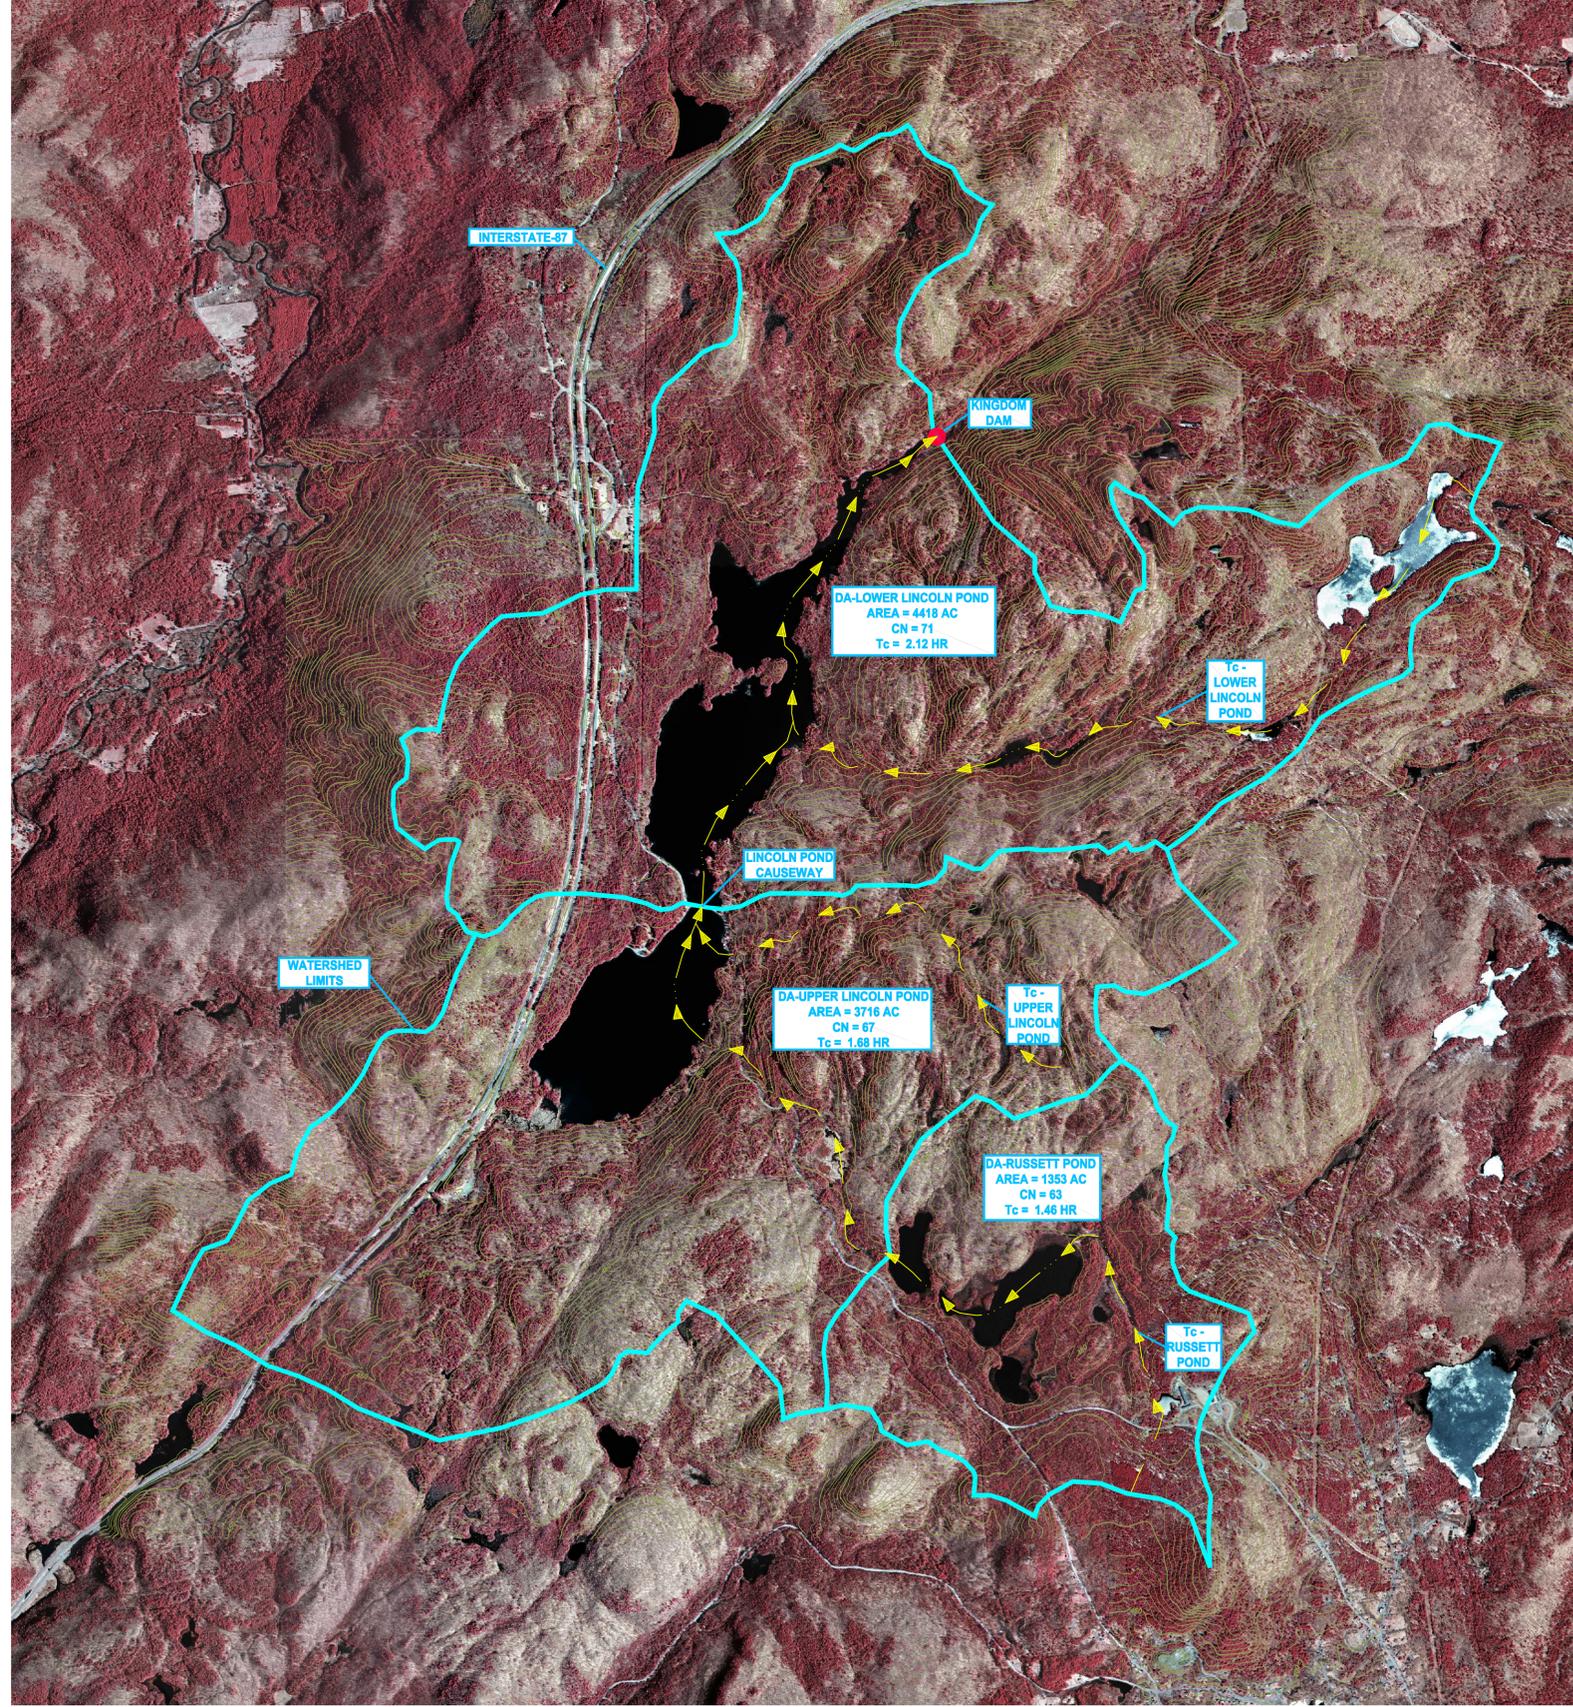
FIG. 5

For the purposes of this hydrologic analysis, the watershed was divided into three (3) subareas ranging from 1350± to 4420± acres (See Figure 5 – Kingdom Dam Watershed). Each subarea represents the runoff directly tributary to one of three (3) principal ponds located within the watershed. The upper most drainage area flows into Tanaher, Mill, Murray and Russett Ponds in the southeastern corner of the watershed (these four interconnected ponds were modeled as a single storage area encircled by the 460 meter (1509 foot) contour with a single outlet to Brandy Brook). The remaining two (2) subareas flow into Upper Lincoln Pond and Lower Lincoln Pond, respectively.
