**Kingdom Dam Phase II Report – Vol. II
Hydraulic and Hydrologic Supplement**

Kingdom Dam on Lincoln Pond

**Town of Elizabethtown
Essex County, New York**

**Re: Kingdom Dam Phase 2 Report – Vol. 2: Hydrologic and Hydraulic Supplement, Lincoln Pond, Essex County, New York
CHA Project No.: 15470**

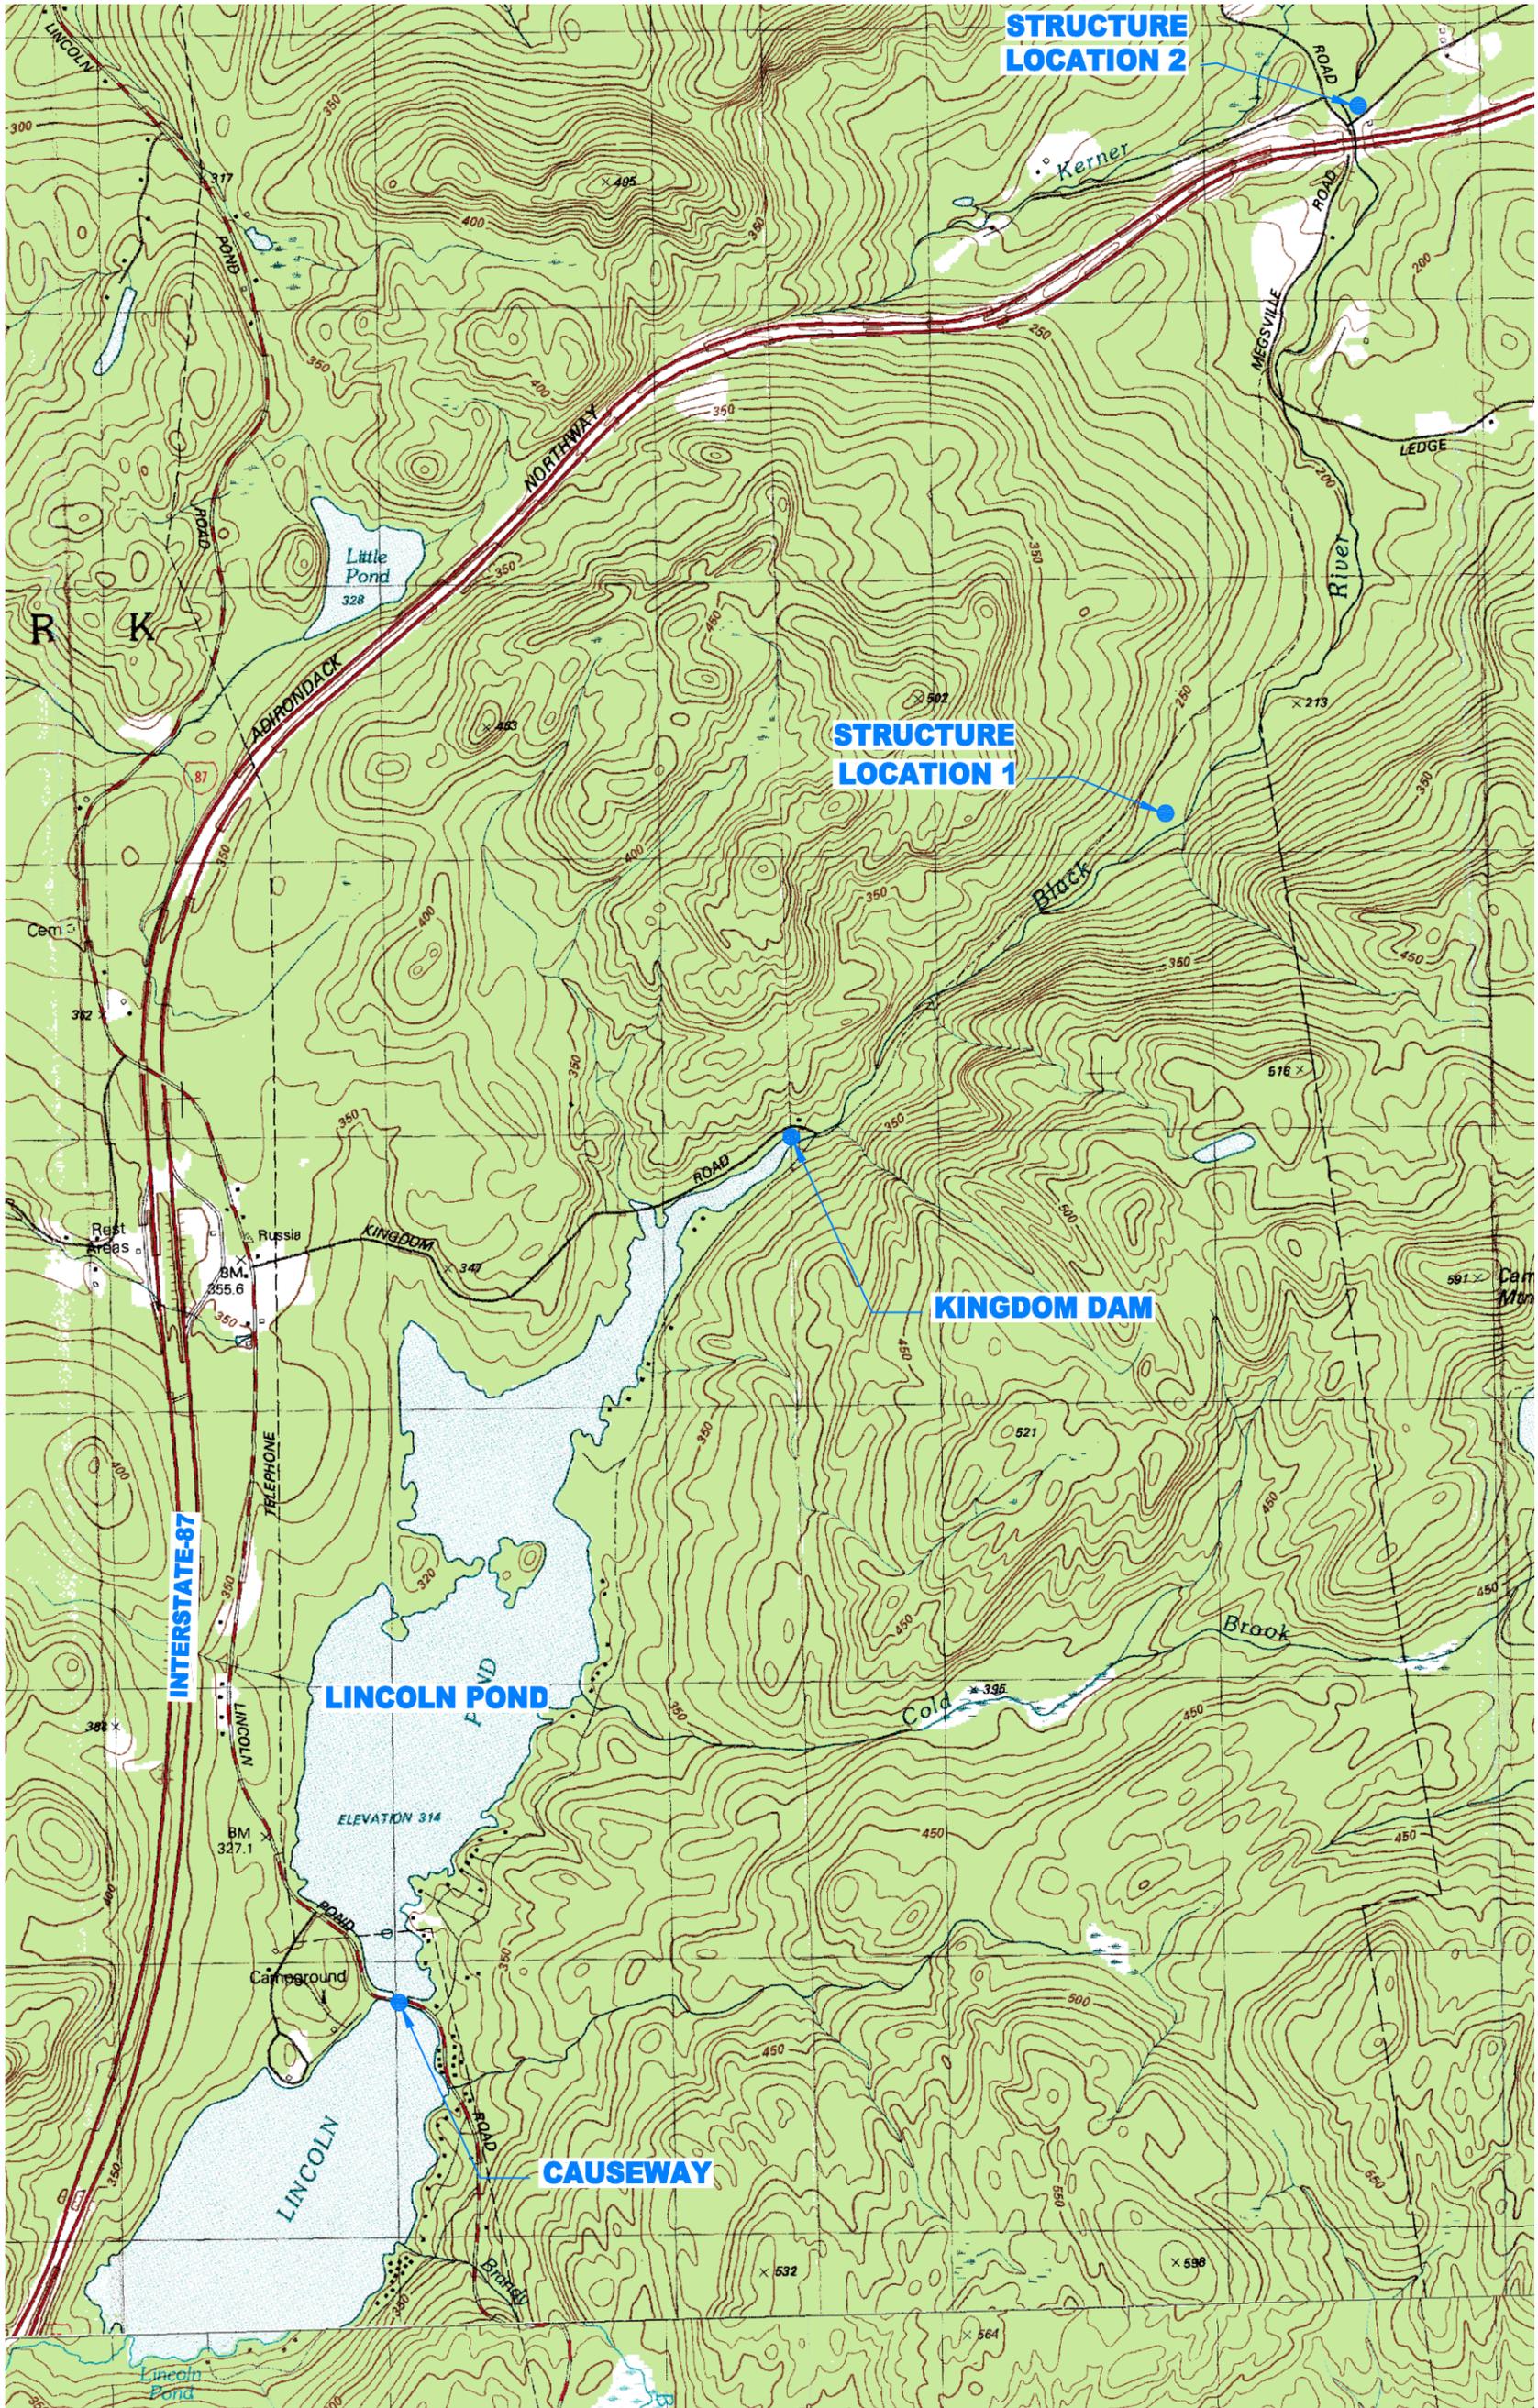
LINCOLN POND CAUSEWAY ELEVATION
KINGDOM DAM PHASE II REPORT
LINCOLN POND
ESSEX COUNTY, NEW YORK

UPSTREAM FACE OF CAUSEWAY
